# HYUNDAI

## Technical Service Bulletin

GROUP <b>RECALL</b>	NUMBER <b>22-01-085H</b>
DATE <b>NOVEMBER 2022</b>	MODEL(S) <b>SANTA FE SPORT (AN)</b>

**SUBJECT:** SANTA FE SPORT (AN) ABS MODULE MULTI-FUSE INSTALLATION (RECALL 237)

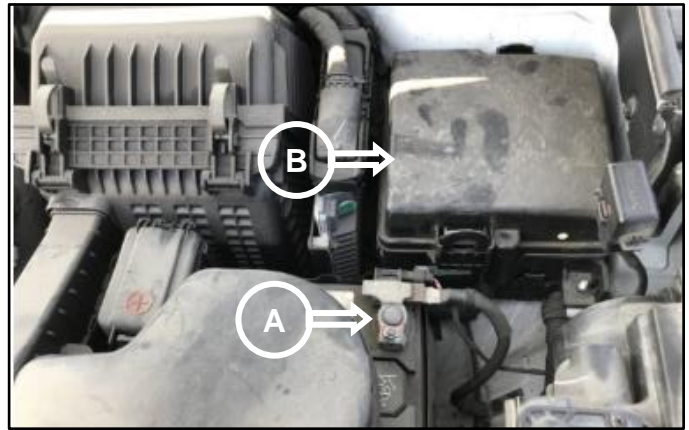
- Disconnect the battery negative (-) terminal (A) and remove the junction box upper cover (B).

**Negative (-) Battery Terminal Nut  
Tightening Torque:  
4.0~6.0 N.m (0.4~0.6 kgf.m, 3.0~4.4 lb-ft)**

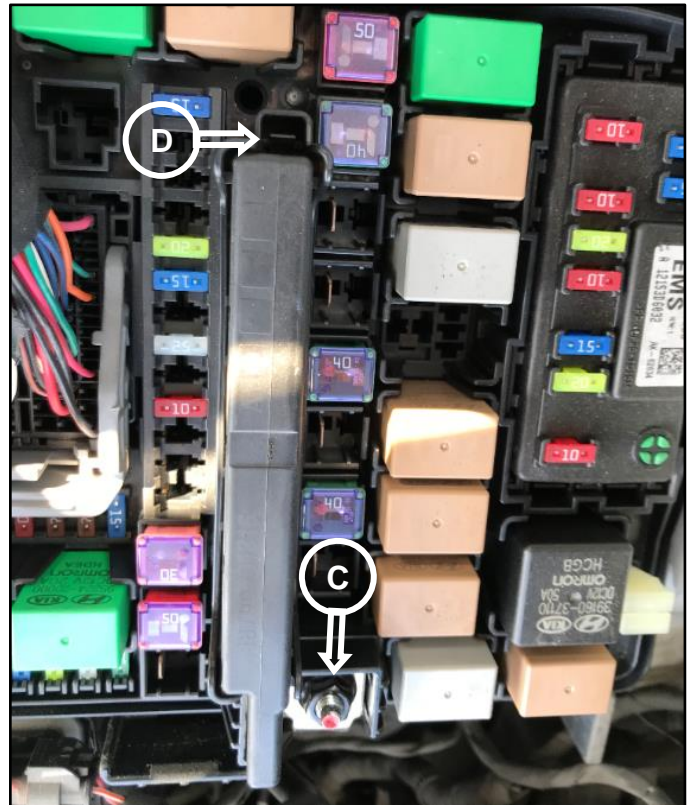
- Remove the 10 mm nut (C) and lift the junction cable over the stud. Release the locking tab (D) and remove the multi-fuse.

**Do not re-use the multi-fuse nor upper cover. A new multi-fuse and upper cover from the service kit must be installed.**

4. Install the new multi-fuse, placing the junction cable over the multi-fuse mounting tab, and the retaining washer on top. Torque the nut to specification.

**Junction Cable Nut Tightening Torque:  
9.8~11.7 Nm (1.0~1.2 kgf.m, 7.2~8.7 lb-ft)**
