HYUNDAI Technical Service Bulletin	GROUP RECALL	NUMBER 23-01-018H
	DATE MARCH 2023	MODEL(S) KONA Electric (OS EV)
SUBJECT: ELECTRIC POWER CONTROL UNIT (EPCU) LEAK INSPECTION AND REPLACEMENT (RECALL 239)

Description: On certain Kona Electric (OS EV) vehicles a low-conductivity coolant may leak inside the Electric Power Control Unit (EPCU) and may cause warning lights to illuminate and/or loss of motive power. The coolant leak is caused by insufficient sealing and housing cleaning omissions. This bulletin provides information on how to inspect the leak and replace the EPCU if a leak is confirmed.

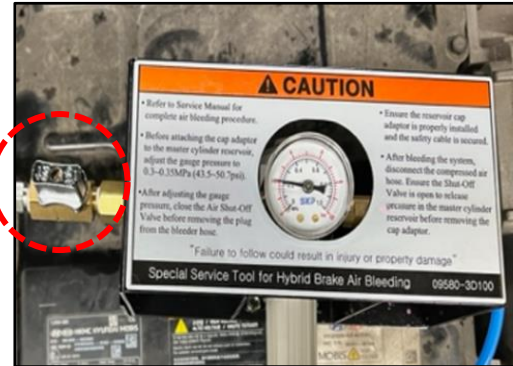
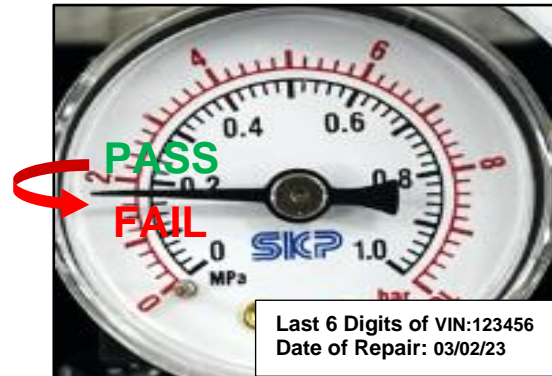
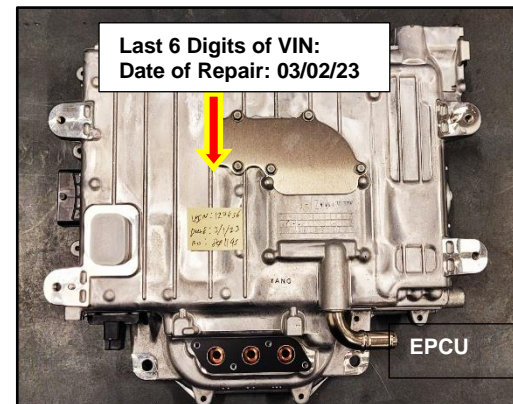
1) **PASS:** If the internal pressure of the coolant is maintained at 1.8 to 2 bar, reinstall vehicle in the reverse order of removal and finish the operation.

2) **FAIL:** If the internal pressure of the coolant is less than 1.8 Bar (the gauge scale has reduced by more than 1 increment), then replace with a new EPCU.

Refer to the shop manual for EPCU replacement:

- Vehicle Control System > Electric Power Control Unit (EPCU)
- **NOTE:** Ignore the EPCU step to perform air tightness check as it is not necessary for the new part.
