To: All Toyota Dealer Principals, General Managers, Service Managers, and Parts Managers  
 Subject: Warranty Enhancement Program ZH6  
 Certain 2005 – 2010 Model Year Tacoma  
 Extension of Warranty Coverage for Frame Corrosion

**IMPORTANT UPDATE****TECHNICAL INSTRUCTIONS****FOR****WARRANTY EXTENSION PROGRAM ZH6, ZH7, ZH8 AND ZH9****FRAME INSPECTION ONLY**

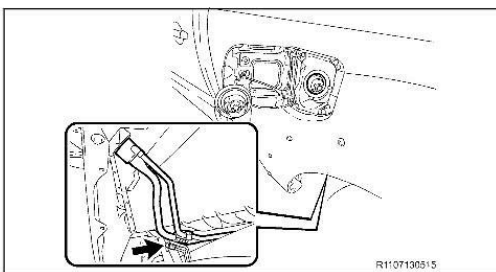
#### 3. REMOVE THE WIRE HARNESS

- Disconnect the clamps, connectors and the frame wire harness from the bed assy.

- The number of connectors may differ depending on the vehicle specification.
- Be careful not to damage the wire harness clamps when removing them.

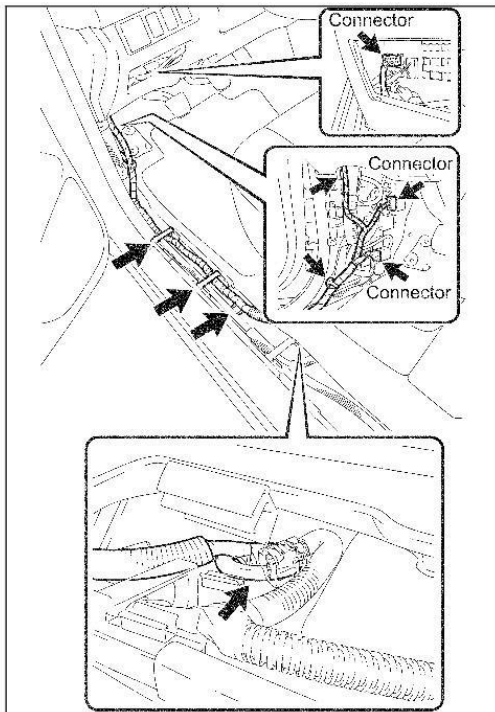
## 7. DISCONNECT THE FRAME WIRE HARNESS

- Disconnect the 5 clamps.
- Disconnect the connector(s).
- Remove the frame wire harness grommet from the cab assy.
- Pull out the frame wire harness from the vehicle cab assy.

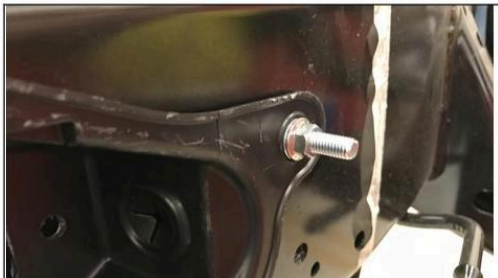
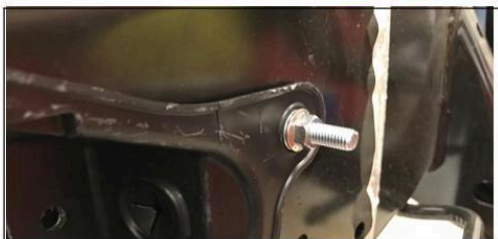
c) Install Frame Seal with Predrilled Hole w/o Weld Nut

1. Using tape secure bolt and washer to the back of the frame as shown.

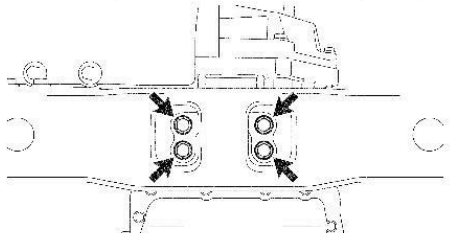
- c) Attach the transmission mount with 4 NEW bolts and torque to spec.

**Torque Spec: 18.5 N·m (189 kgf·cm, 14 ft·lbf)**

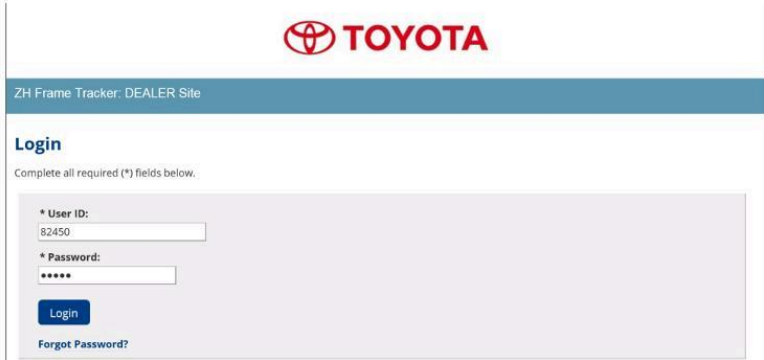
**15. RECORD THE FRAME SERIAL NUMBER**

- a) Log into the frame tracker website using your dealer code and password.  
 URL: <https://zh-frame-tracker.imagespm.info/> Default password: xxxxx

b) Select 2005 to 2010 Tacoma ZH6 from the pick list.
