HYUNDAI Technical Service Bulletin	GROUP RECALL	NUMBER 23-01-018H
	DATE MARCH 2023	MODEL(S) KONA Electric (OS EV)
SUBJECT: ELECTRIC POWER CONTROL UNIT (EPCU) LEAK INSPECTION AND REPLACEMENT (RECALL 239)

Description: On certain Kona Electric (OS EV) vehicles a low-conductivity coolant may leak inside the Electric Power Control Unit (EPCU) and may cause warning lights to illuminate and/or loss of motive power. The coolant leak is caused by insufficient sealing and housing cleaning omissions. This bulletin provides information on how to inspect the leak and replace the EPCU if a leak is confirmed.

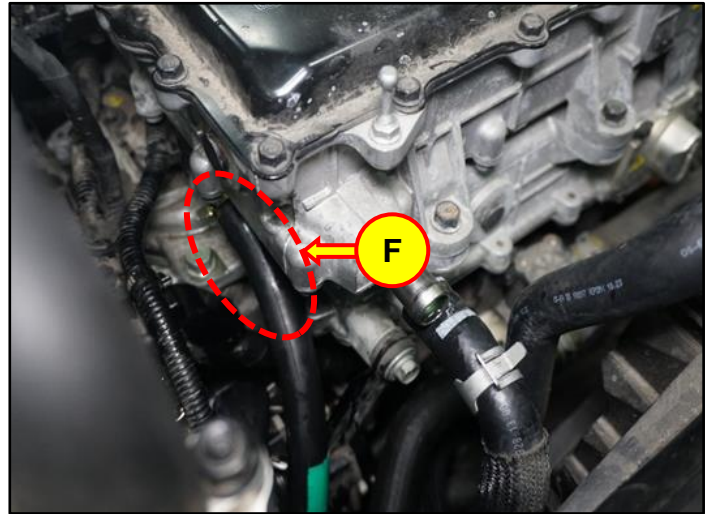
1. Feed the discharge hose through to the bottom of the vehicle to a bucket placed underneath to catch coolant that will be discharged from the hose later.

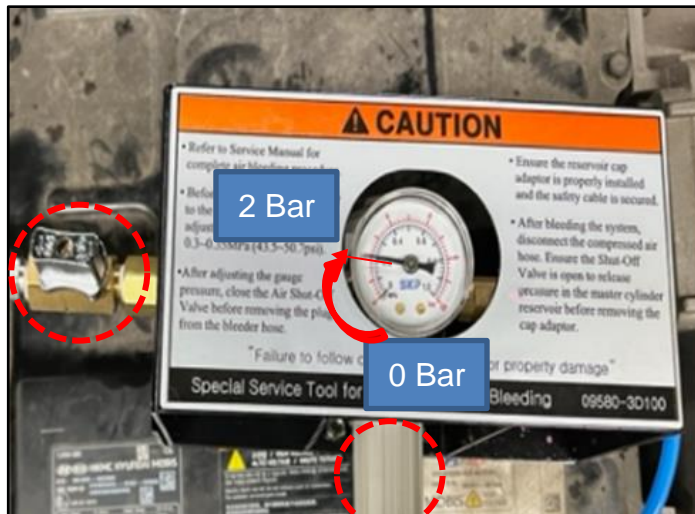
3. Remove the air hose after setting the air bleeding tool to 2 Bar.

When pressurized using the air bleeding tool, any instantaneous increase in pressure other than the set pressure of 2 bar, can cause the EPCU and OBC to fail.

10. Lock the pressure valve and check that it is airtight after 30 minutes.

1) **PASS:** If the internal pressure of the coolant is maintained at 1.8 to 2 bar, reinstall vehicle in the reverse order of removal and finish the operation.

2) **FAIL:** If the internal pressure of the coolant is less than 1.8 Bar (the gauge scale has reduced by more than 1 increment), then replace with a new EPCU.
